PHASE I INSPECTION REPORT
NATIONAL DAM SAFETY PROGRAM

**EAST FORK, ROCK CREEK DAM
(FLINT CREEK PROJECT)
CLINTON, MONTANA
GRANITE COUNTY
MT-15**

PREPARED BY:
CH2M HILL
BELLEVUE, WASHINGTON

MAY 1980

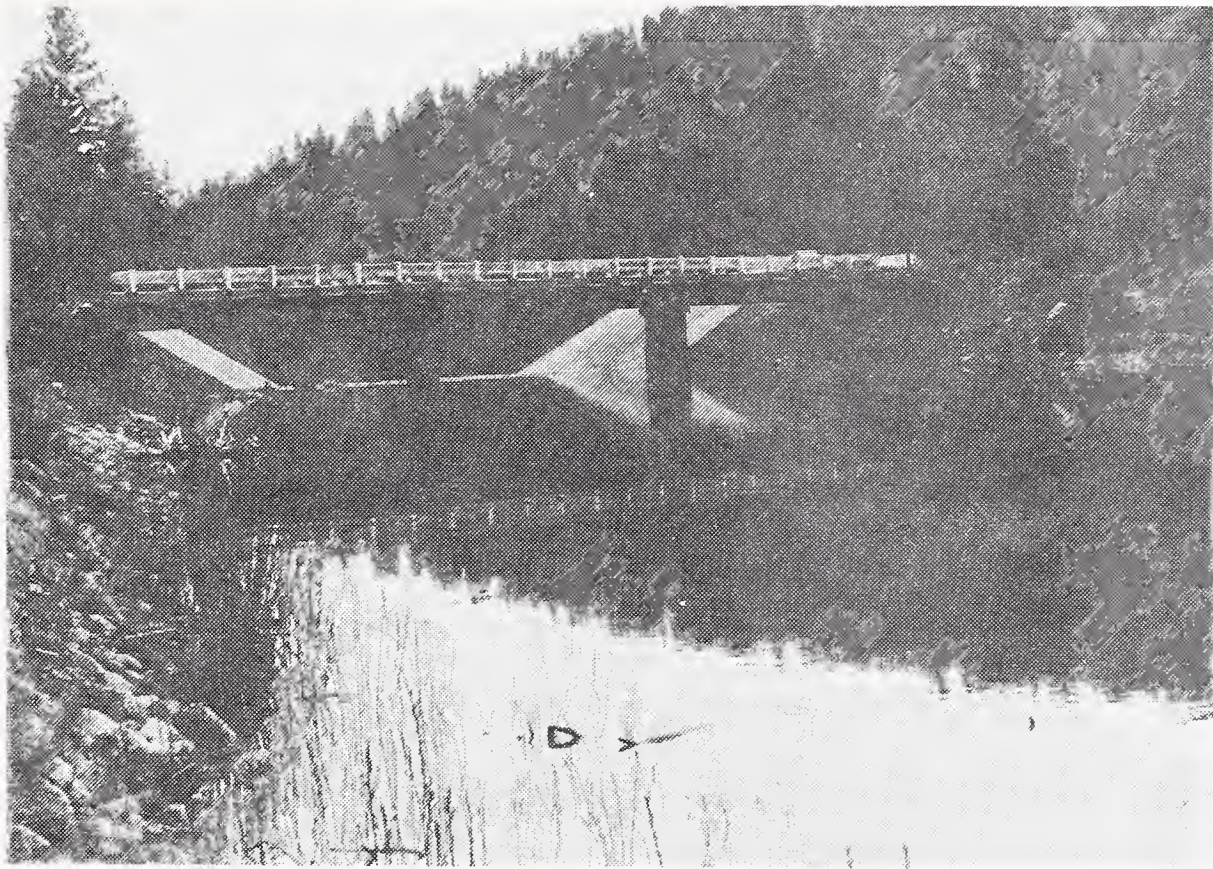
(PHOTO 1) Flint Creek (East Fork Rock Creek) Dam
Spillway approach channel.

2. Inspect the areas on or near the butterfly valve for cavitation damage and repair as required.
3. Construct a log boom to protect the spillway from floating debris. The boom should be placed in the reservoir near the entrance of the approach channel with its ends positioned so it functions for all reservoir levels.
4. Install weirs and monitor all seepage. During a normal high pool, obtain water samples of seepage near the embankment toe and conduct tests to determine if soil fines are being transported.
5. Drain the immediate downstream toe area to facilitate inspection for seepage.

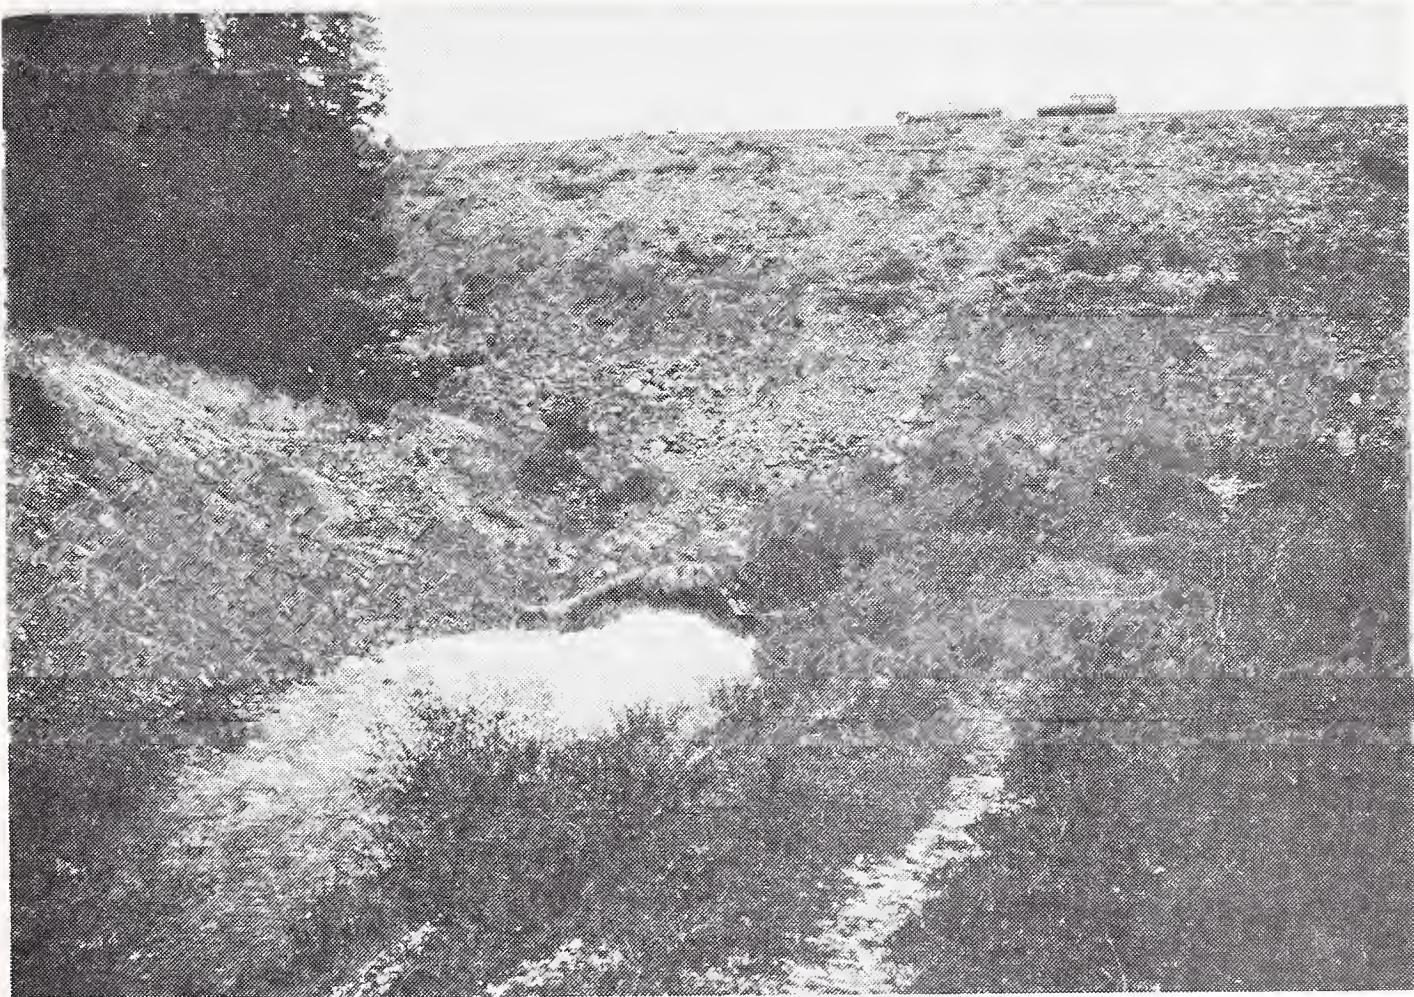
The outlet structure consists of a pair of walls about 20 feet in length. The walls show considerable spalling caused by freeze/thaw action. The flow discharges to an excavated channel at the end of the outlet structure (Plate 2). The channel is neither eroding nor backcutting.

(PHOTO 2) Outlet channel and Right abutment .

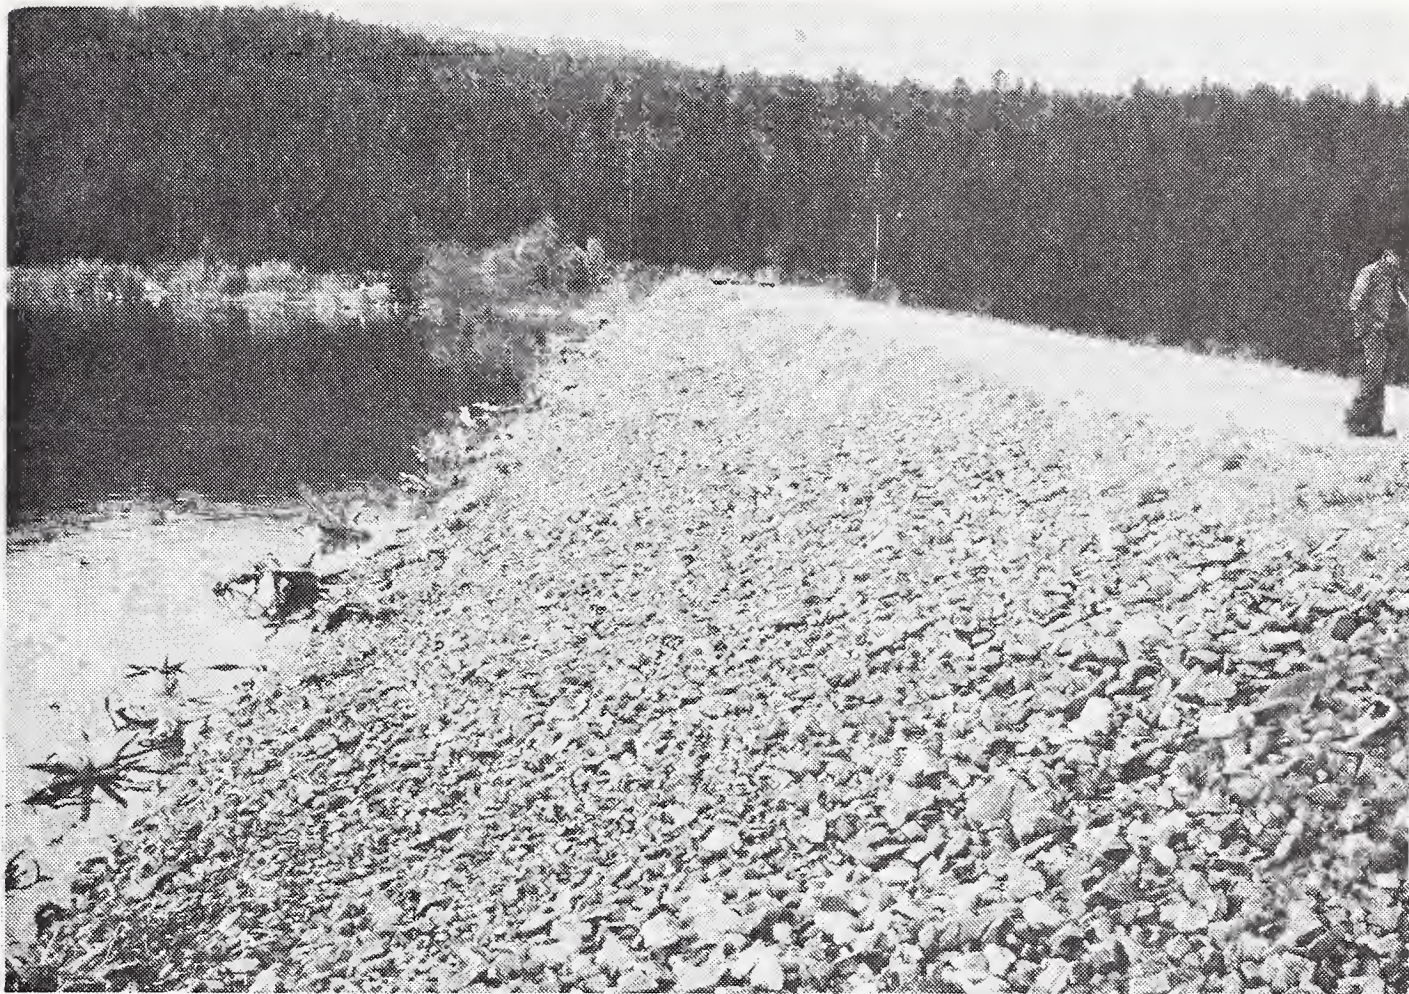
The upstream slope is protected from erosion by a covering of 12-inch-minus riprap. The actual riprap thickness is unknown; however, the specifications indicate that riprap was to be 18 inches thick over a 6-inch bedding layer (Photo 3). The downstream embankment slope had a sparse covering of brush (Photo 4). No slope erosion, irregularities, slumps, or cracks were present on the dam crest or slopes.

(PHOTO 3) Embankment Upstream Slope.

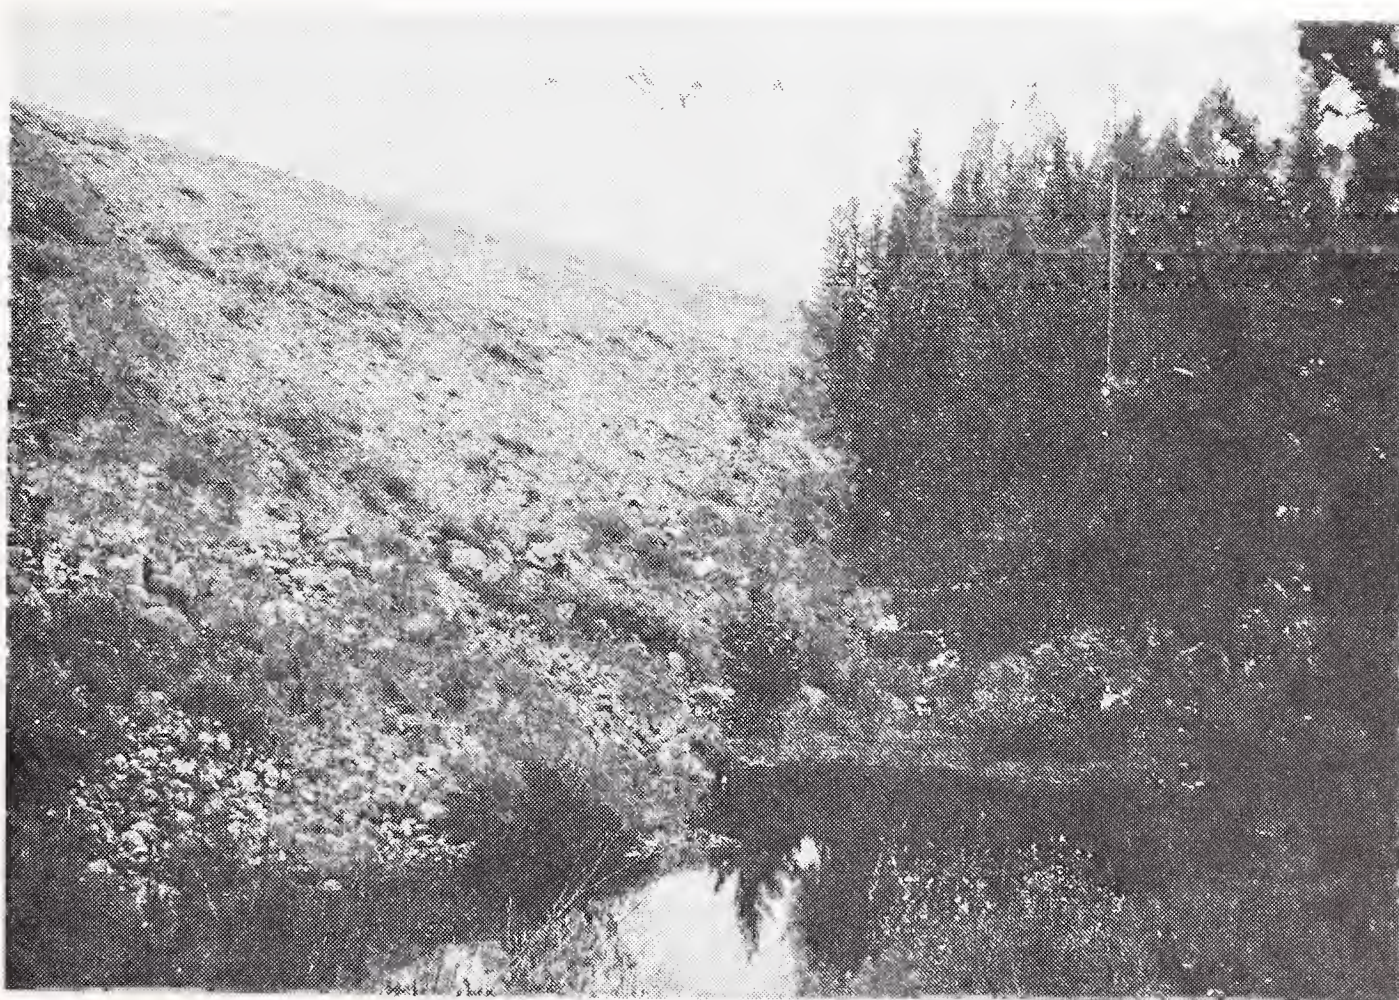
During the June 7, 1979, inspection, seepage of about 4 gpm was observed at the downstream toe near the left abutment contact (Photo 4). Seepage of about 40 gpm was observed downstream of the embankment toe and near the right abutment (Photo 5). The flow appeared to emerge along the contact between the overburden sandy clay and the alluvial sand and gravel sediments. The source of this seepage may be from the outlet conduit discharge channel as the invert of the channel is 2 to 3 feet above the seepage exit. Minor erosion was observed at the seepage exit (Photo 5). No mention is made of this seepage in the September 26, 1977, inspection report by the Department of Natural Resources. However, in a letter written after the first filling of the reservoir in 1940 (Ref. 8), the following statement is quoted:

(PHOTO 4) Seepage at Downstream Slope near Left Abutment.

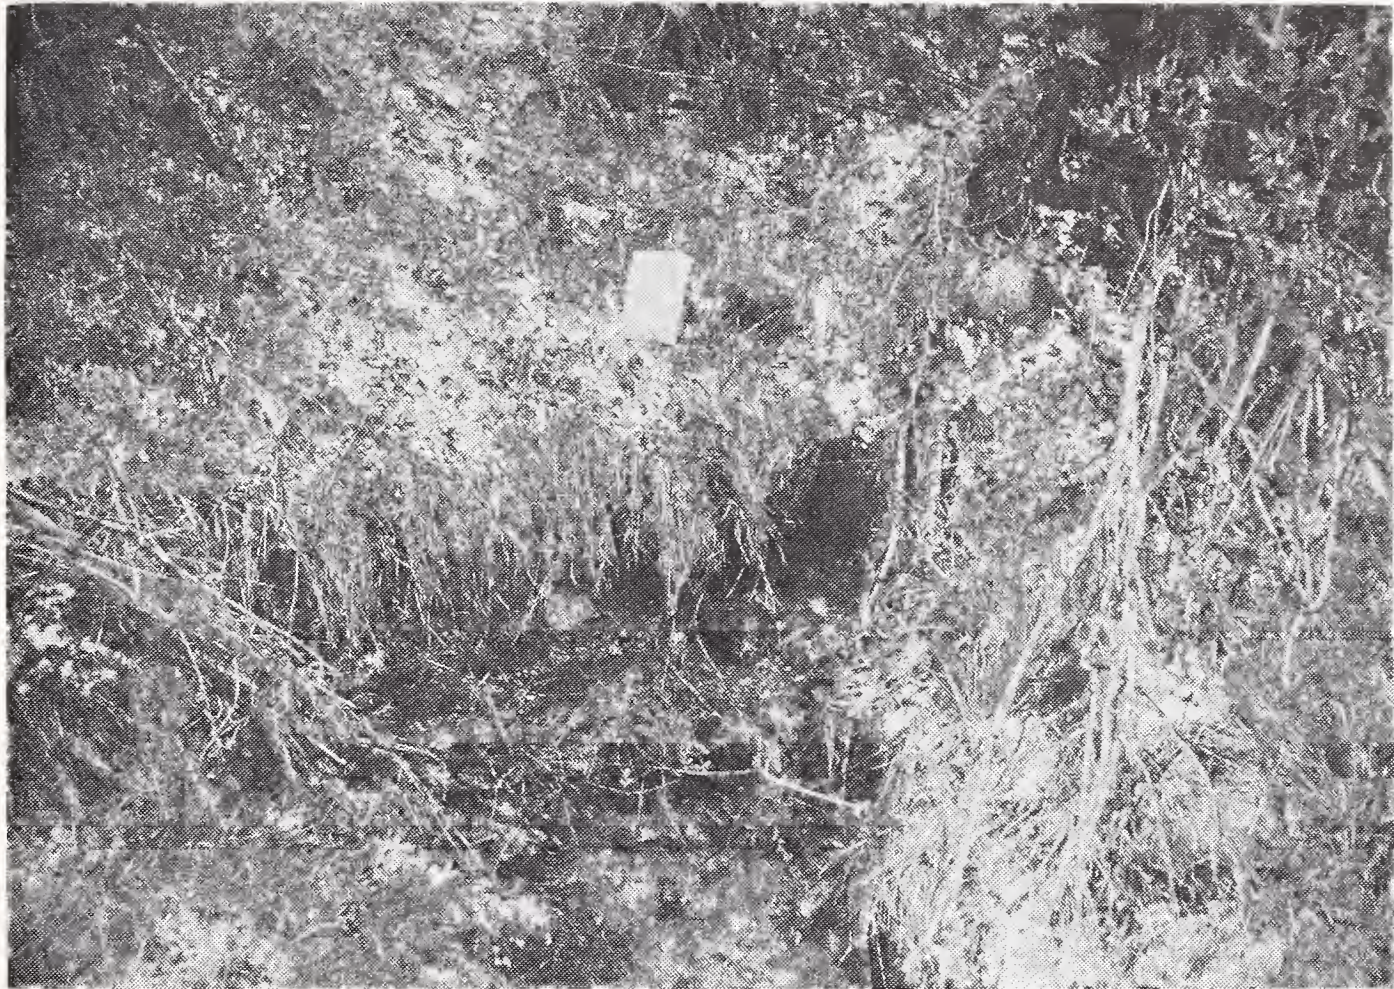
A visual inspection of the dam revealed neither longitudinal or transverse cracking nor any embankment, abutment contact, or toe erosion. Seepage observed at the downstream embankment toe and at the right abutment toe did not appear to be adversely affecting embankment stability. However, seepage observed in the Beaver Ponds downstream of the embankment is considered to be underseepage from the reservoir. The exact amount of this seepage or the exiting areas could not be determined during our inspection. Therefore, additional work needs to be performed to determine whether soil fines are being transported. Also, there are no piezometers in the dam and the position of the phreatic surface within the dam is unknown.

(PHOTO 5) Seepage at Right Abutment Toe.

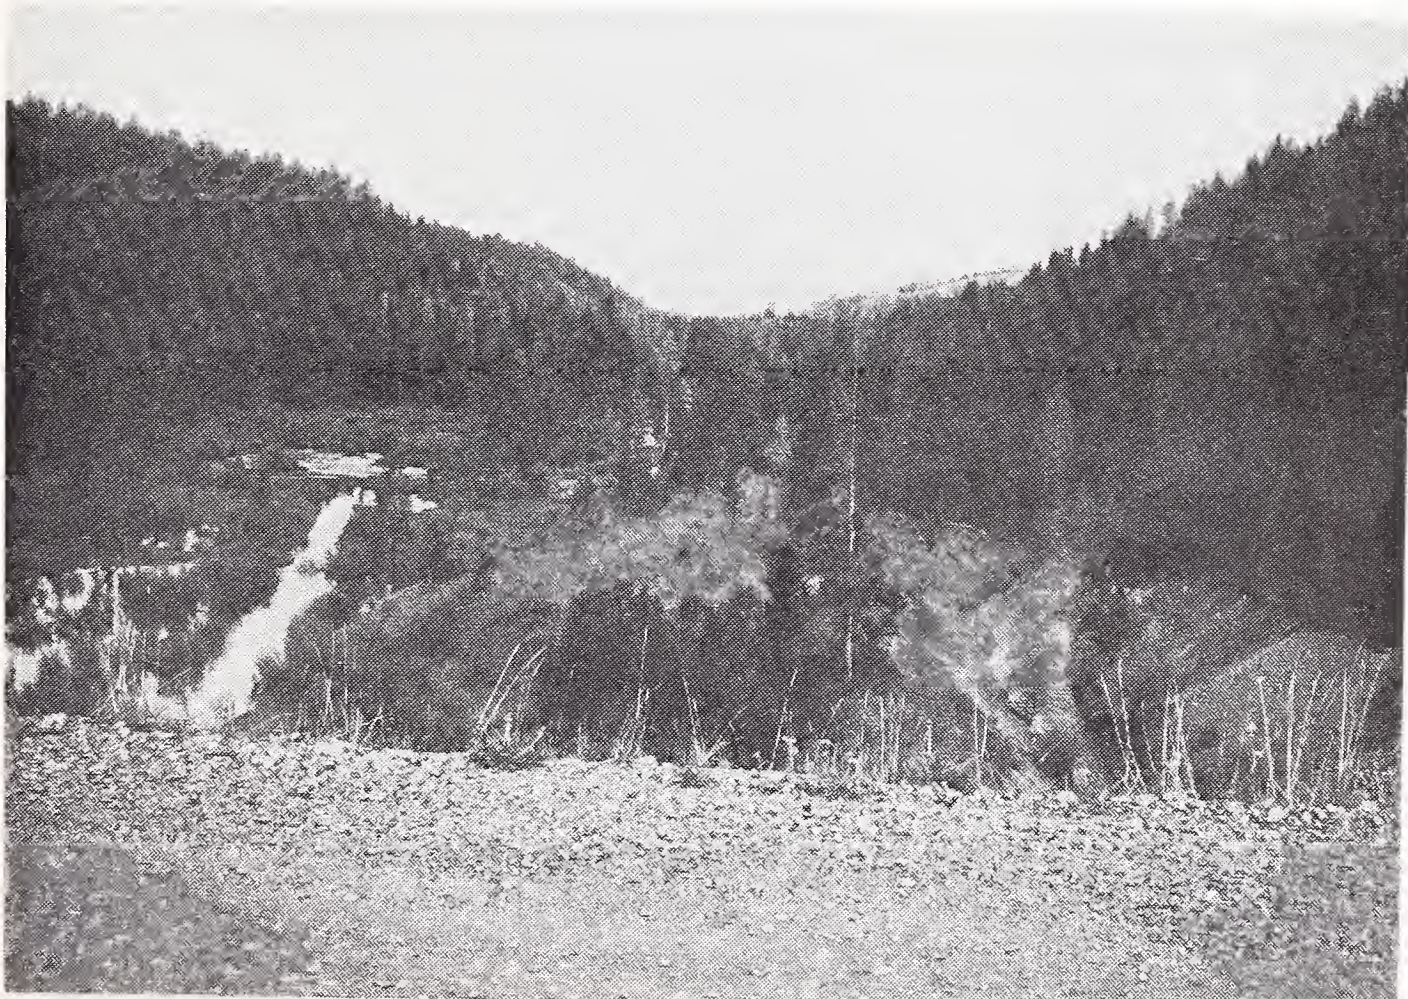
At the time of the June 7, 1979, inspection, the channel downstream of the embankment toe could not be inspected for seepage because of ponding water created by beaver dams (Photo 6). The pond water was clear, which would suggest that fresh water was coming into the pond probably from seepage under the embankment and the quantity may be more or less than that observed at first reservoir filling in 1940 (Ref. 8).

(PHOTO 6) Ponding Downstream of Embankment.
